| <b>Notification No.:</b> | 20081113 | <b>Revision:</b> 1.0 | <b>Page:</b> 1 of 2 |
| <b>Description:</b> | UBA Frame Modification | | |
| <b>Hardware:</b> | UBA all models | | |

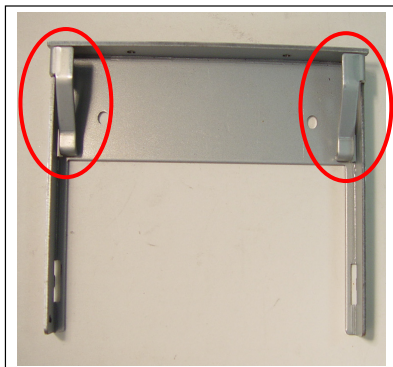
Figure 1

Frame Base

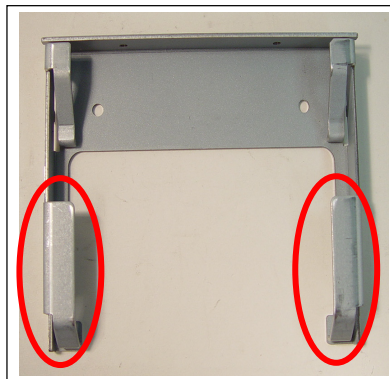
Figure 2

New Frame Base

JCM Engineering has developed a modification for the base of frames used in the UBA units. The original base plate has two supports at the rear (Refer to Figure 1). The frame modification has two added supports at the front of the base plate (Refer to Figure 2). This helps to support and properly align the cashbox when it is inserted into the frame. The new base plate is shown installed in the frame. (Refer to Figure 3).

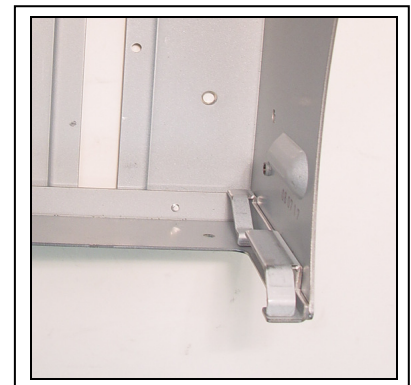
Figure 3

Installed In Frame
