Customer Notification

Notification №.:	20081114	Revision: 1.0	Page: 1 of 2
Release Date:	Nov 14, 2008		
Notification Status:	🛛 Advisory	Mandatory	Announcement
Classification:	Firmware	🛛 Hardware	Policy/Procedure
Description:	UBA Frame Modification Retrofit		
Hardware:	UBA all models		
Interface:	n/a	Check Sum: n/a	
Firmware Version(s):	n/a	CRC (seed = 0000)	n/a

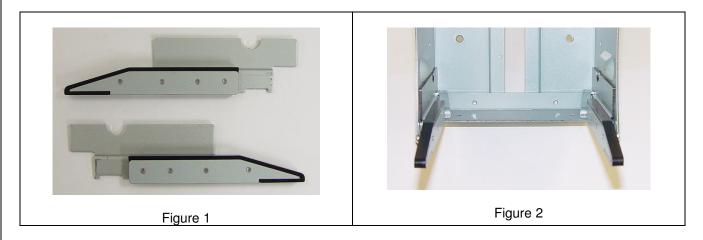
JCM Engineering has identified a condition where excessive forceful insertion of a cashbox into a UBA frame can cause damage to the TR stand.

JCM Engineering has developed a retrofit kit for the frame used in the UBA units (Kit UBA Frame Retrofit, P/N 701-100090R). The frame modification consists of two ramps that attach to the frame (Refer to Figure 1). These ramps support and align the cashbox when it is inserted into the frame. (Refer to Figure 2)
