Notification No.: 20140815		Version: 1.0	Page: 1 of 2			
Release Date: August 15, 2014 Effective Date: August 15, 2014						
Notification Sta	tus: X Advisory	☐Mandatory	☐ Announcement			
Classification:		e 🛚 🖾 Hardware	☐ Policy/Procedure			
Description: iVIZION Cash Box Stacker Guide						
Hardware: Ca	sh Box Stacker Assembly	Territo	Territory: All			
Interface: N/A	A	Check	Check Sum: N/A			
Firmware Versi	on(s): N/A	CRC (s	CRC (seed = 0000): N/A

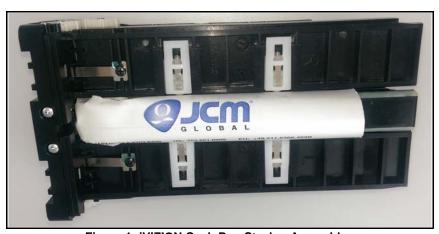
JCM Engineering has received reports of improperly stacked Tickets in the iVIZION Validator's Cash Box (refer to Figure 1 below). The Ticket's trailing edge may catch on the Stack Guide, moving it to a vertical position. The Stack Guide Spring may also be moved out of position. (Refer to Figure 2 on reverse to view these conditions.)

Figure 1: iVIZION Cash Box Stacker Assembly with Ticket Jam (Abnormal)

An investigation by JCM Engineering determined that this condition is caused by the Drive Motor turning off early as a Ticket is pulled into the Cash Box. The iVIZION software v.2.11-xx (USA and Canada) has been updated to keep the Drive Motor active longer to ensure that Tickets fully enter the Cash Box.
